**Final Environmental Restoration
RFCA Standard Operating Protocol
for Routine Soil Remediation
FY04 Notification #04-05
IHSS Group 700-2**

December 2003

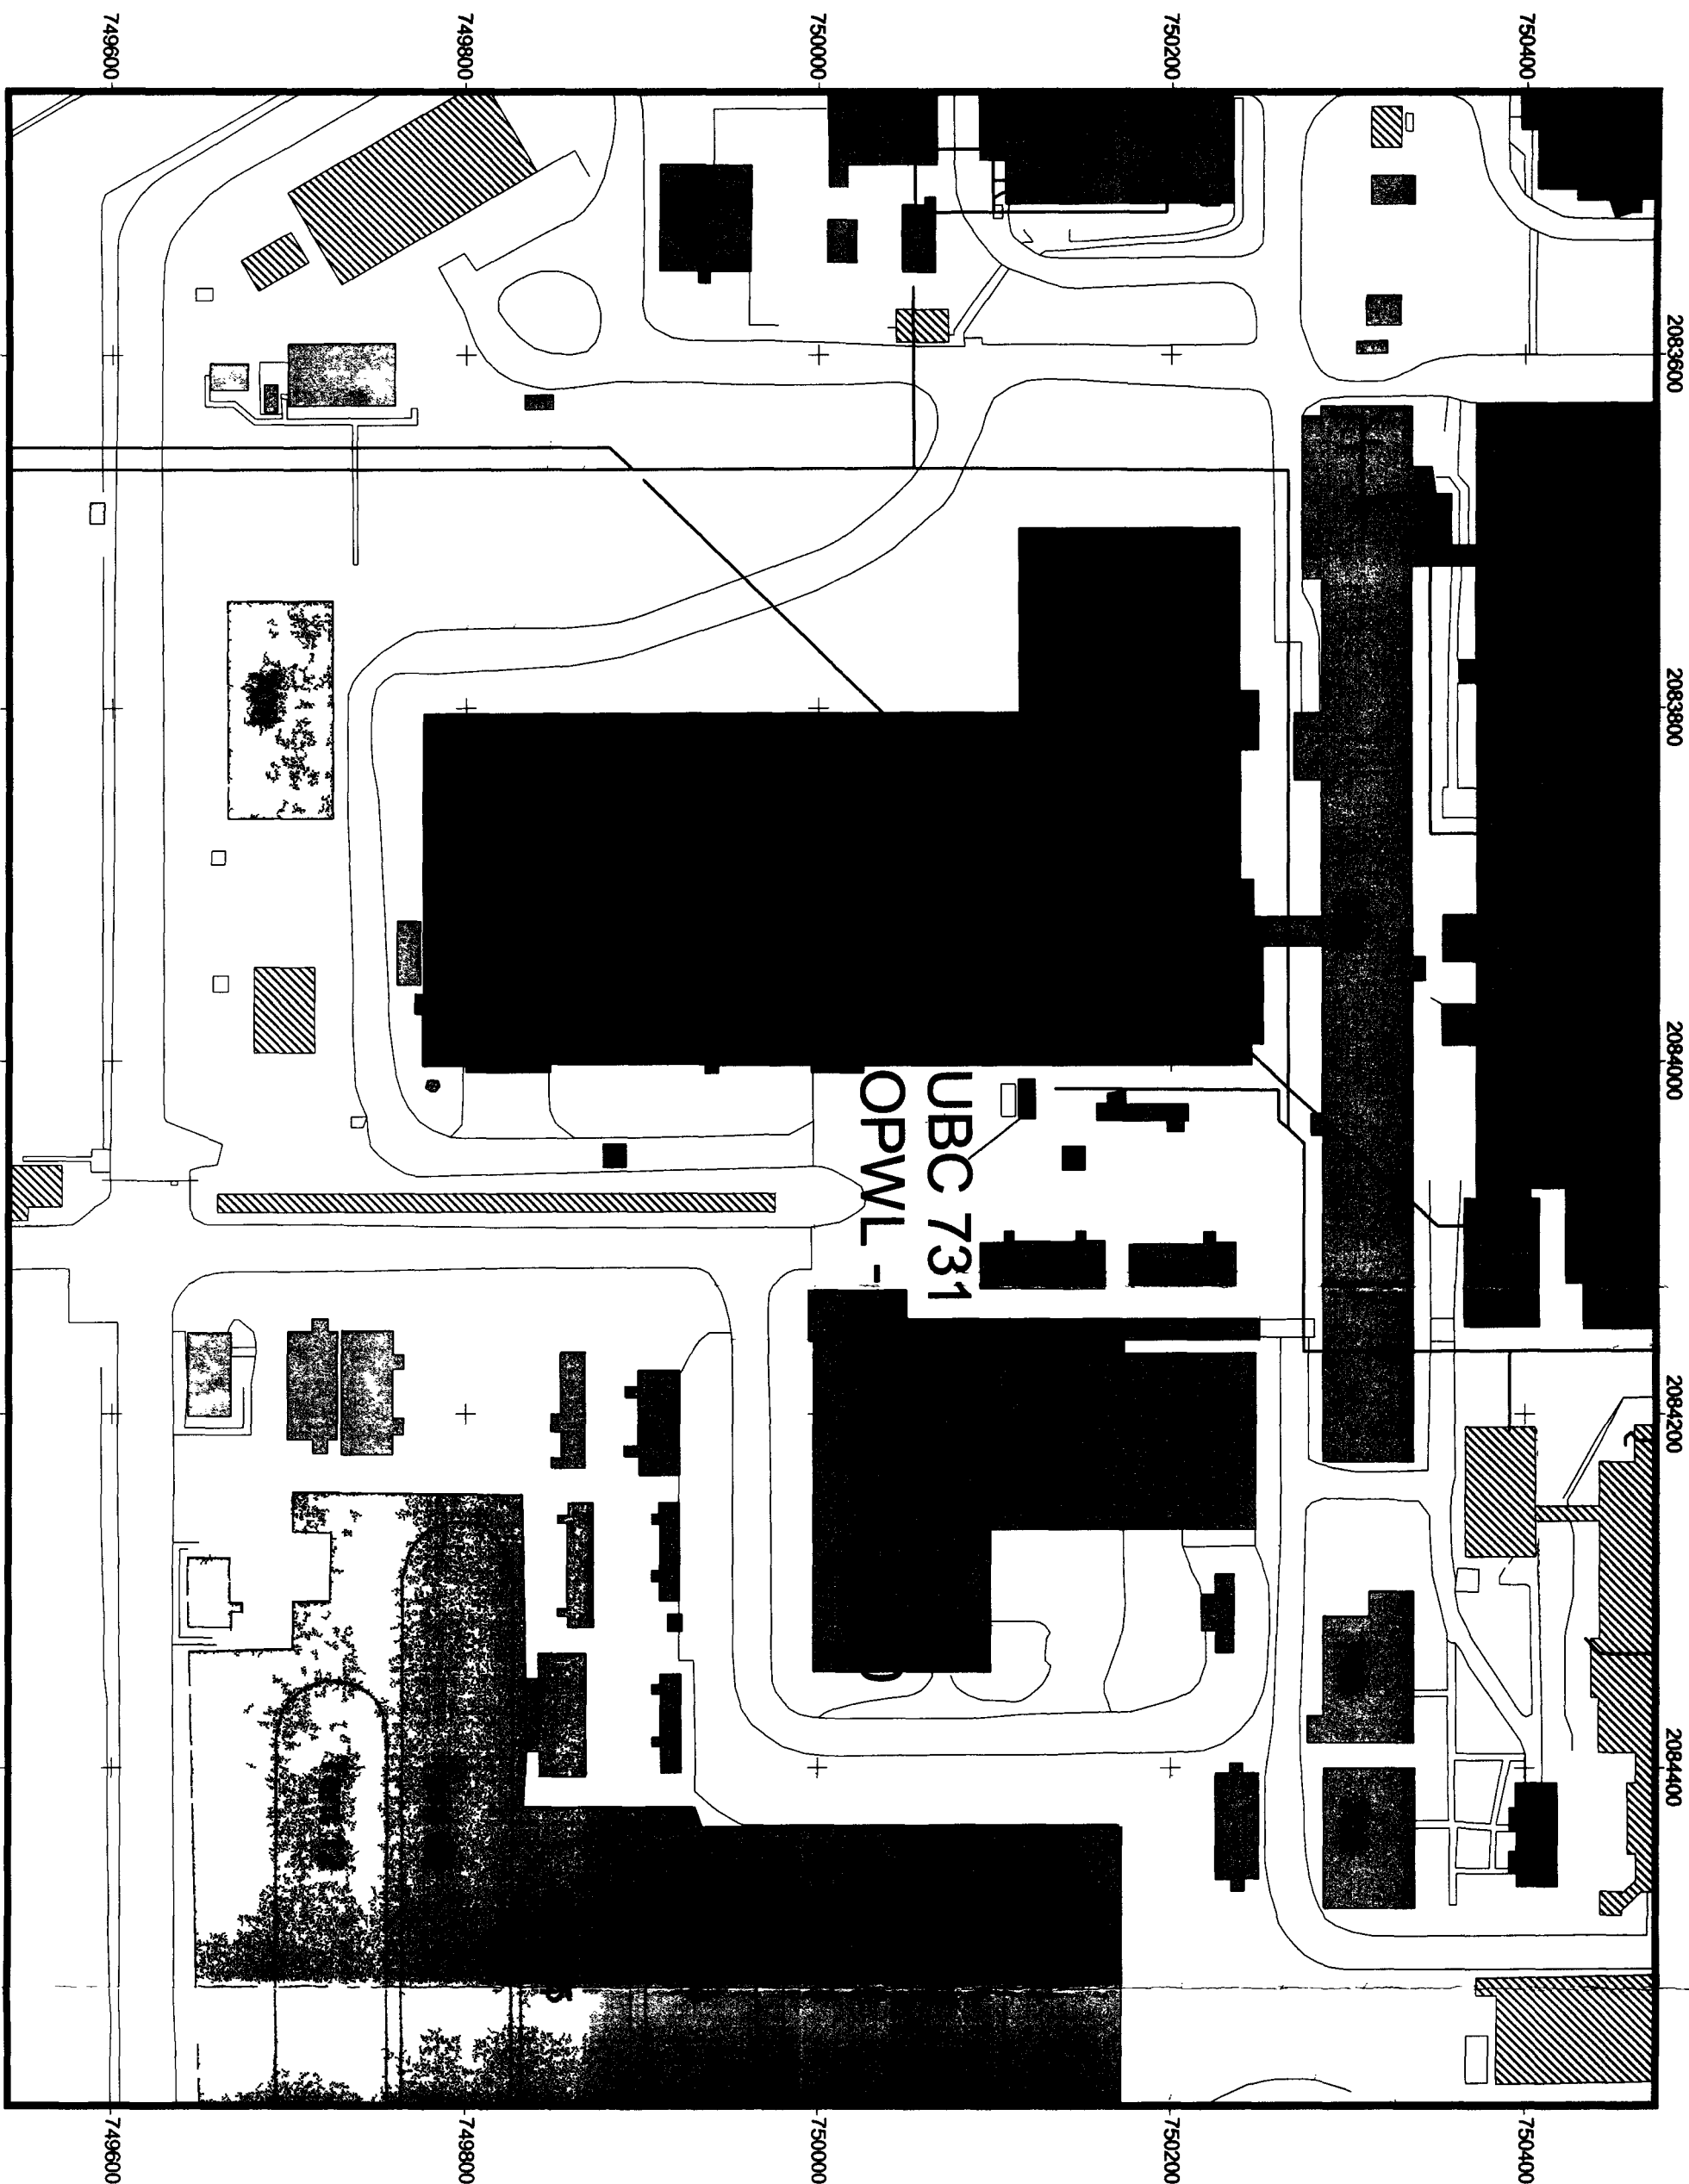
Figure 2
IHSS Group 700 2
Potential Remediation Areas

Based on the PCOCs (Table 1) and the ER RSOP (DOE 2003a), it is anticipated that all contamination above RFCA ALs will be remediated. Figure 2 shows the potential remediation areas (IHSS and UBC sites)

High-volume air samplers may be used at the remediation area consistent with work controls to determine airborne radioactivity concentrations. Approximate locations of air samplers are shown on Figure 2.

IHSS Group 700-2 is shown on Figure 1. The UBC and IHSS sites are shown on Figures 2. The proposed remediation sites covered under ER RSOP Notification #04-05 are listed in Table 1.
